Micro analysis of the structure of the boiler pipe after experiencing the heating process and without heating

Mulia ¹, Suardi ², Hendra Susilo ³

^{1,2,3} Jurusan Teknik Mesin, Universitas Tjut Nyak Dhien, Medan, Indonesia

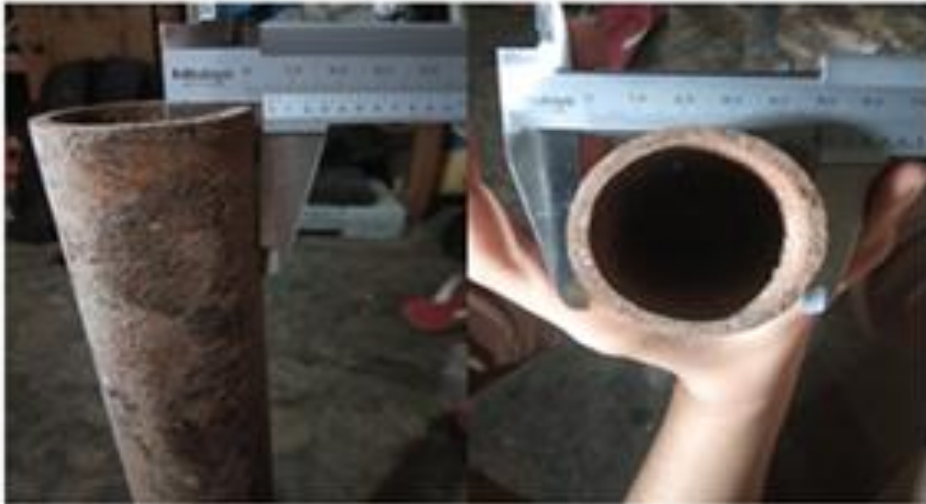
The initial size of this standard material has an inner diameter of 40mm and an outer diameter of 50mm, during the combustion process the material undergoes changes from scale / corrosion and friction from the fluid which results in thinning the surface of the inner pipe hole.

Figure 2. Size of pipe material before and after corrosion

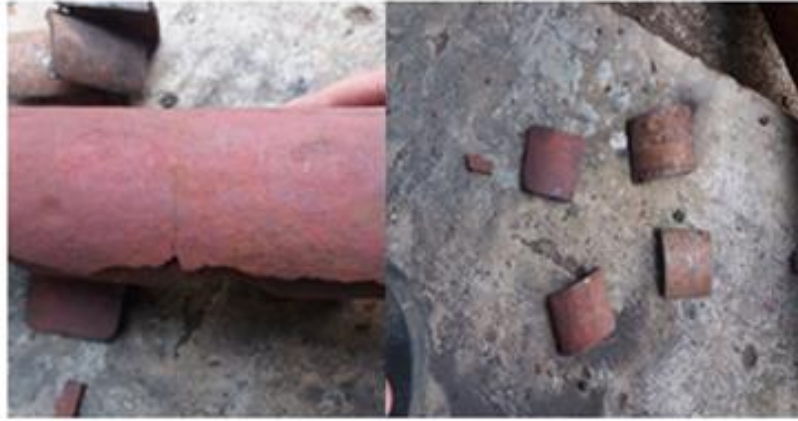
Figure 4. Pipe pieces that have undergone combustion activity

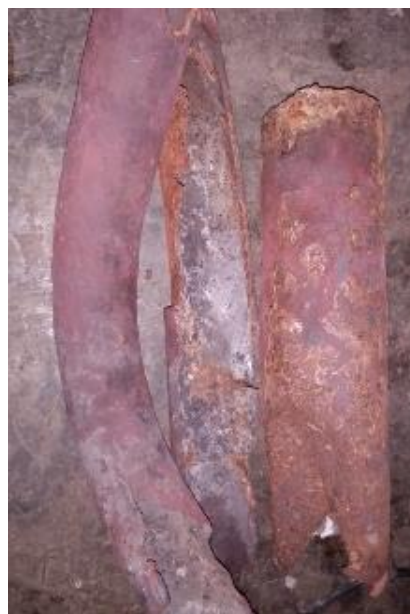
Visual testing is a test used to see how severe the damage is to a material and becomes a benchmark for determining the type of damage that occurs to the material..

Figure 6. Pieces of pipe that have failed/damaged

Because of the heat, the pearlite phase that already exists in the pipe steel can change due to the heat received in the long term. This will change the phase of the pearlite steel. The phase change from pearlite to ferrite causes the hardness to decrease, as a result it is prone to leakage. The superheater platen pipe is traversed by hot steam with a fairly fast flow, so this can cause high pressure in the pipe. Coupled with bends that result in friction with the wall is even higher. Due to the high friction and the material changing phase to ferrite which has less hardness than pearlite, the steam flow erodes the pipe elbow. Hence, leakage at the elbow of the superheater platen pipe occurred (see figure 6).

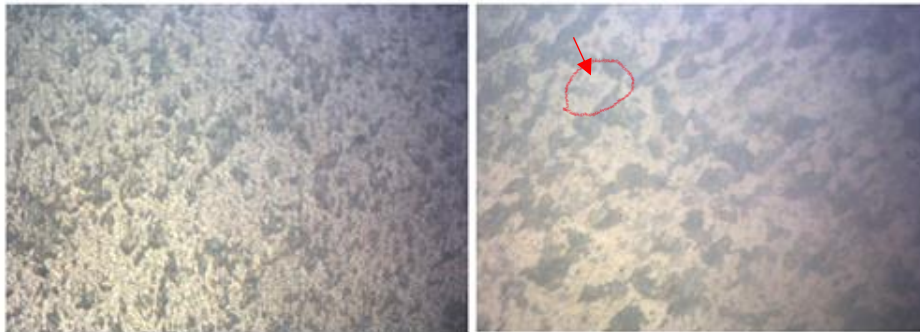
Image of specimen A using 200 x magnification

Image of specimen A using 500 x magnification

Figure 7. Observation Results of Specimen A

Obtained from the picture above. explains that the microstructure formed is a ferrite and pearlite microstructure. Where, the black area shows the pearlite area and the white area shows the ferrite area. Specimen A which is a material that has not received heat treatment has a microstructure, where the condition of the fearlite area is greater than specimen B with heat treatment. In the picture of the metallography test results it is concluded that the damaged pipe has lost a lot of pearlite area. The amount of pearlite microstructure shows the hardness of a material. The more microstructure in the form of pearlite, it can be said that the structure of the object will have a high level of hardness. Meanwhile, in the picture of the test results above, the pearlite area disappears, so it can be said that the pipe has begun to lose its hardness and the pipe becomes prone to leakage. The formation of phases in steel, such as pearlite is due to heat treatment. Different heat treatments produce different phases of steel. Boiler pipes experience continuous heat exposure.

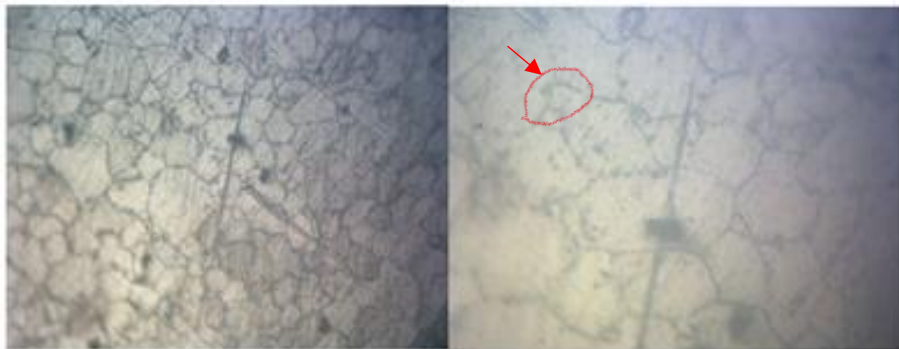
Image of specimen B using 200 x magnification

Image of specimen B using 500 x magnification

Figure 8. Observation Results of Specimen B

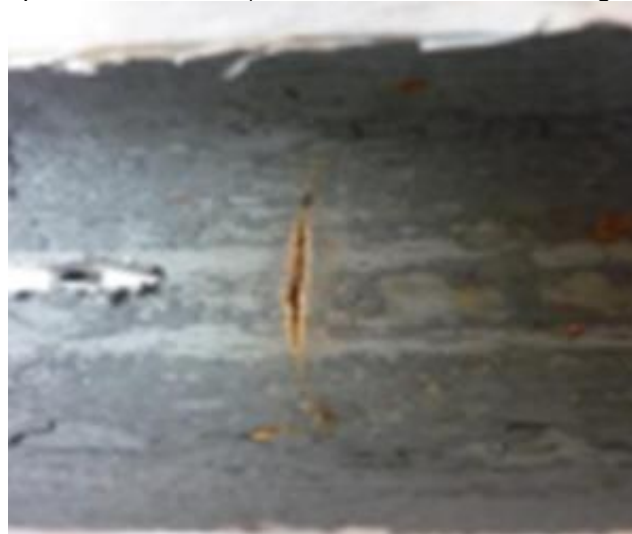
Figure 9: Material that has cracked resulting in a hole

Another additional explanation that may need to be added is that the pipe failure is creep due to operating at high temperatures and pressures (overheating) with long operating times and followed by softening (annealing) so that erosion occurs by the fluid in the pipe which causes thinning of the pipe so that the pipe cannot withstand the workload and failure occurs.

Appropriate alloying to improve corrosion resistance is one possible strategy to counteract the pipe corrosion problem. The service life of the pipeline will be longer for steel alloys or higher nickel alloy alloys. However, the effects of using such alloying materials are not easy to predict (effects such as chemical reactions, etc. in the duct and turbine follow-up of the pipeline). Alloys with less iron and more nickel, chromium, molybdenum, etc. also increase the price, making the choice less economically viable (Kappenthuler & Seeger, 2021). However, if the effects are predictable, i.e. do not produce harmful compounds (will cause rust, etc.), the application of such alloys would be economically advantageous, unless there are frequent severe fluctuations in steam temperature due to frequent sensor failures, etc. Another explanation that may need to be added is that the occurrence of pipe voids originates from fatigue at high temperatures, which results in the formation of voids in the material. These voids will meet and merge to form intergranular cracks. Intergranular cracks that merge will form larger and larger cracks. Due to the large number of cracks, the material becomes vulnerable and material perforation occurs (Goda & Girardot, 2021; Zhang et al., 2020).
