Identification of flow mark defect on haitian MA 1200 machine in the molding process at PT. Philips Industries Batam

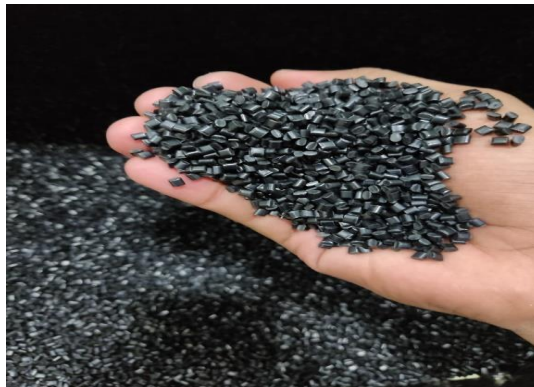
Figure 2. Acrylonitrile butadiene styrene (ABS) material

The plastic material used in the production process with the Haitmanan MA 1200 molding machine employed by PT. Philips Industries Batam is Acrylonitrile Butadiene Styrene (ABS). Figure 2 shows the type of ABS plastic used in the production process.

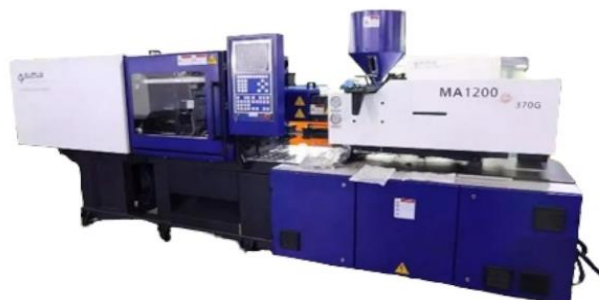
Figure 3. Haitian MA 1200 molding machine

Figure 3 shows the molding machine used by PT. Philips Industries Batam, namely the Haitian MA 1200 machine. In the process of converting plastic ore from ABS material, it is melted at a temperature of 180°C to 240°C (Iman Mujiarto, 2005).

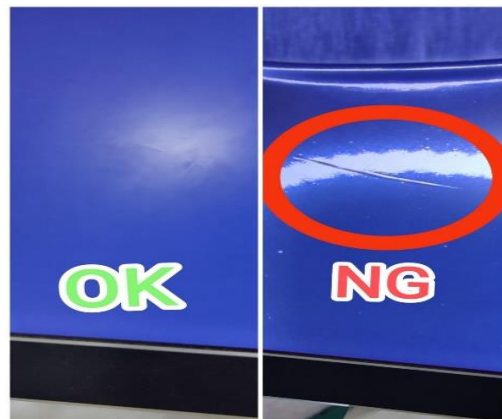
Figure 4. Flow mark defects

From Table 1, it can be concluded that the flow mark defect is the most common defect with a quantity of 127 defects. There have also been reports of flow mark defects in the molding machine when ABS plastic is used (Ikhwan & Yuliastuti, 2024). Flow mark is a product defect characterized by flow lines or streaks that have a negative impact on the product. The defect shows up when there is an irregular flow of liquid material, which leaves marks on the part's surface. Numerous factors, including as machine capacity, mold shape, plastic material, and parameter settings, are typically responsible for this problem. The parameters include cooling time, injection pressure and speed, injection and filling time, material melting temperature, ejection

pressure, mold temperature, and melt speed (Arif et al., 2024; Devalia & Arief, 2019; Ikhwan & Yuliasuti, 2024). An example of a flow mark defect can be seen in Figure 4.

Based on the results of five trials of injection molding parameters listed in Table 3, effective parameter settings were obtained to improve the flow mark defect. This optimal setting consists of start post settings: inject 1 with a value of 63, inject 2 with a value of 42, pressure settings: inject 1 with a value of 165, inject 2 with a value of 155, and pressure settings: hold 1 with a value of 55, hold 2 with a value of 45, as well as flow settings: hold 1 with a value of 18 and hold 2 with a value of 13. These parameter settings successfully reduced the flow mark defect on the Haitian MA 1200 machine.

During the 5 trials, the researchers took product samples with the new parameter settings to check for the flow mark defect. Upon checking the samples, no flow mark defects were discovered. By applying the correct repair parameters, the test results showed the absence of flow mark defects after the repair process. This indicates the effectiveness of the implemented repair method in addressing the issue. The achievement demonstrates the importance of accurate parameter settings in ensuring the final product quality. Thus, the corrective actions taken have yielded satisfactory results and improved the overall integrity of the product. A key factor in improving product quality and reducing defects is parameter optimization in the injection process for plastic materials (Lase & Arwati, 2025). Additionally, Changes in injection molding process parameters may also affect mechanical strength and esthetics such as gloss and other defects (Ozcelik et al., 2010; Tsai et al., 2009). However, this is not the focus of this research.

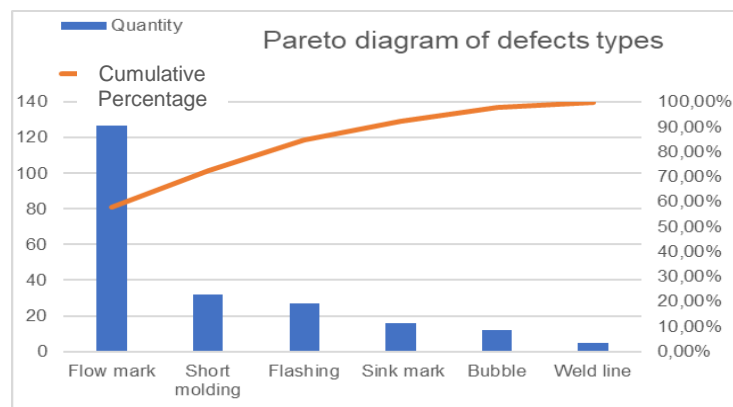
Figure 5. Pareto diagram

This is the defect data from the Haitian MA 1200 machine from December 2023 to February 2024. this data is analyzed using a Pareto diagram. The Pareto diagram can be seen in Figure 5.

From this Pareto diagram, it can be seen that the highest percentage of cumulative defects is the flow mark defect with a total of 127 defects. This diagram yields a proportion of 57.99% out of the 100% total number of defects. The defects identified through the 80/20 Pareto method show a percentage value exceeding 20%, which is a main requirement in seeking solutions to reduce defects.

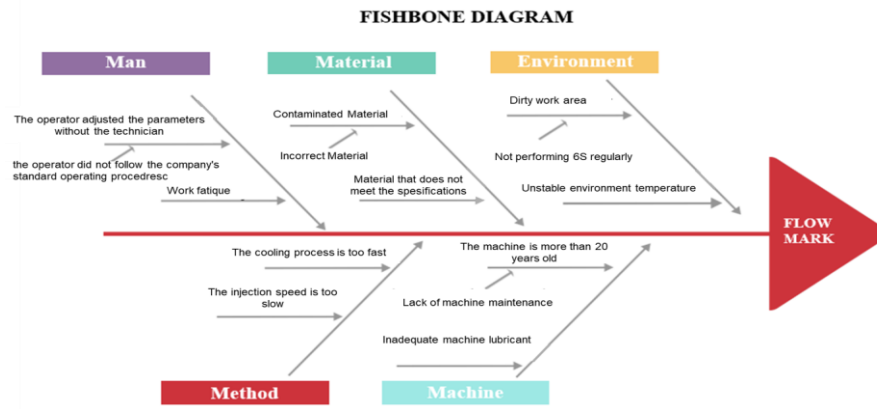
Figure 6. Fishbone diagram

The fishbone diagram is used to analyze the problems that occurred previously, which can be seen in the Pareto chart. The fishbone diagram in this study is shown in Figure 6.

Figure 6 shows that the issue is caused by five distinct factors. The issue is caused by man, material, machine, method, and environmental factors. The use of the fishbone diagram is analyzed with components labeled "NO" and "YES," and the purpose of these components is to identify the causes of the flow mark defect. Table 2 shows the root cause analysis based on the fishbone diagram.

The potential interaction between the factors of method, machine, material, and man can be analyzed using a fishbone diagram to map the causes of existing problems based on the results of field testing and direct observation. From the analysis above, it can be seen that the method factors (cooling and injection processes) are the main causes contributing to the flow mark defect, labeled "YES". Meanwhile, other factors, although tested and analyzed, were not proven to be the main causes, thus labeled "NO". This helps in determining a more precise and effective focus for improvement efforts.
