Micro analysis of the structure of the boiler pipe after experiencing the heating process and without heating

Mulia ¹, Suardi ², Hendra Susilo ³

^{1,2,3} Jurusan Teknik Mesin, Universitas Tjut Nyak Dhien, Medan, Indonesia

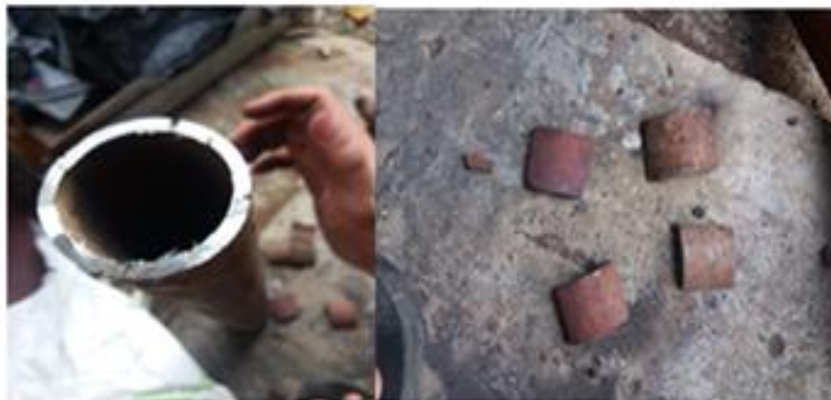
Figure 3. Specimen Pipe Raw Materials

Post pipe pieces used in factory boilers and cut into smaller sizes to facilitate the data search process.
